Case Studies in Construction Materials

Corrosion assessment of reinforced concrete elements of Torre Velasca in Milan

Federica Lollini*, Elena Redaelli, Luca Bertolini

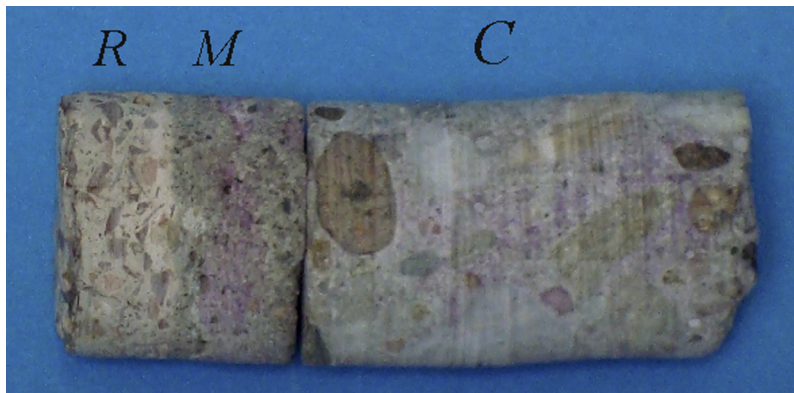
Sixty five core samples, taken from the different elements, were analysed to assess the nature of the different materials that cover the steel reinforcement and to measure the carbonation depth. Their observation showed the presence of three layers: an external render (*R*), an intermediate mortar (*M*) and the structural concrete (*C*) (Fig. 3). The layer of render was usually adherent to the layer of mortar, which, conversely, was often detached from the underlying concrete. Both the render and the mortar appeared very dense with a low porosity: absorption values of 7.3 and 7.9% were respectively measured, as average value of two samples, on the render and mortar, whilst on concrete an average value of 5.2% was detected. The thickness of each layer showed a great variability: the thickness of render *R* was in the range 5–27 mm, whilst the thickness of mortar *M* was between 5 and 50 mm (Table 1). As a consequence, the total thickness (*R* + *M*) showed a great variability with values between 12 and 75 mm. The average values were 13 and 17 mm for render and mortar, respectively, and about 30 mm for the total thickness.

Fig. 3. Typical stratification of a core ($\Phi=26$ mm) taken from a pillar and designation of layers: R=render, M=mortar, C=structural concrete.

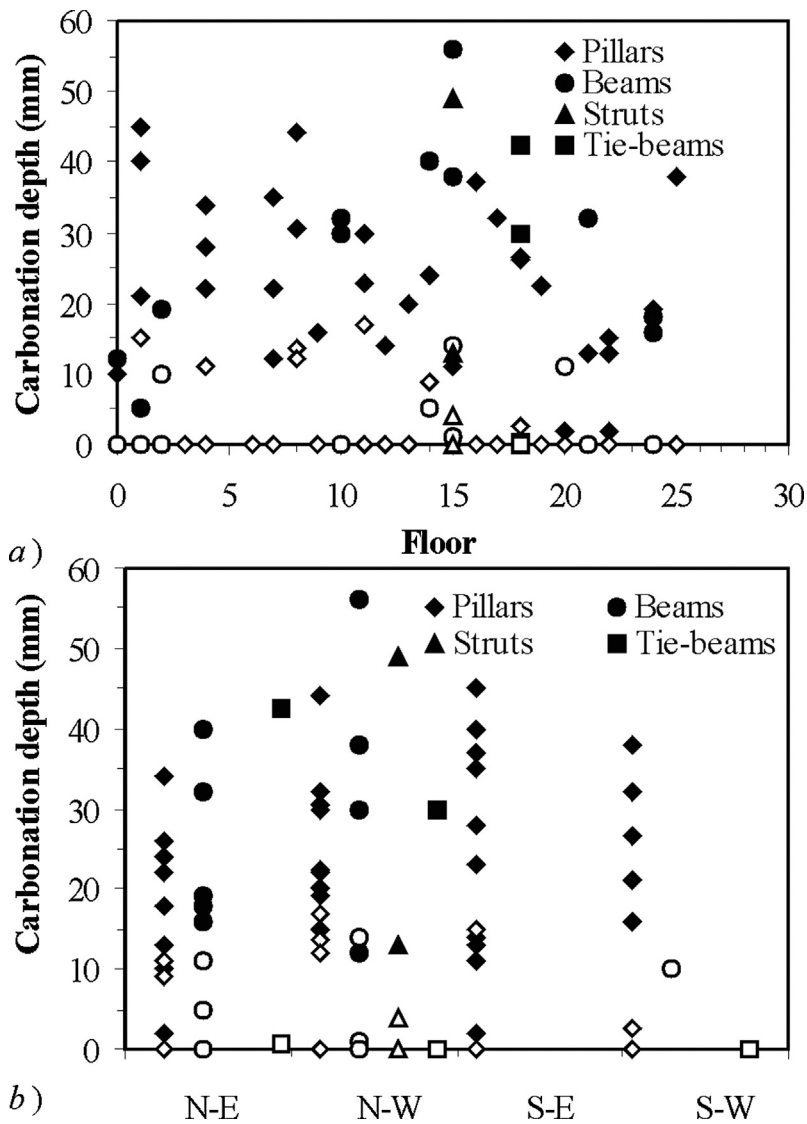
Regarding carbonation, in most of the samples the layer of render *R* was fully carbonated, while the carbonation depth of concrete was negligible. The total carbonation depth measured from the external surface ranged between 0 and 56 mm (Table 1). To investigate on possible factors influencing the carbonation depth, results of phenolphthalein tests were plotted versus the position of sampling. Fig. 4 shows, for each type of element, the carbonation depth as a function of the height (expressed as floor number) and orientation. Both the total carbonation depth (filled symbols) and the carbonation depth of the structural concrete (empty symbols) are shown. A systematic effect of either the type of structural element or the local exposure condition did not emerge. For instance, carbonation depths measured on cores taken from the intermediate part of the tower (from 16th to 18th floor), which is sheltered from the rain, were comparable with those measured on the lower and upper parts of the tower. This may be due to the variability of results, which is greater than the effect of local environmental parameters.

Fig. 4. Carbonation depth as a function of the floor (a) and orientation (b) where specimens were cored (filled symbols: total carbonation depth; empty symbols: concrete carbonation depth).

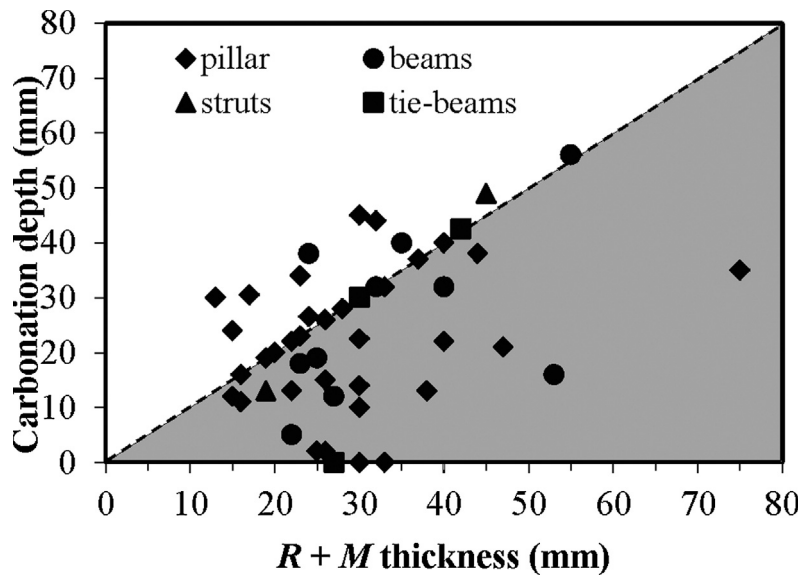
In order to investigate on the role of render and mortar layers on the penetration of carbonation, Fig. 5 shows the total carbonation depth as a function of the thickness of *R* + *M* layers: the grey area groups specimens with a carbonation depth that is lower than *R* + *M* thickness (i.e. concrete was alkaline), while the white area groups specimens where even concrete was carbonated to some extent. It can be clearly observed that in most specimens the carbonation front lays within *R* or *M* layers and, hence, the underlying concrete was barely carbonated. At the time of inspection, i.e. after about 50 years of exposure, even in the specimens with a *R* + *M* thickness of only 13 mm, the carbonation depth of concrete was lower than

20 mm. When R+M thickness was higher than 30–40 mm, carbonation of concrete was almost completely prevented, indicating that the render and mortar layers had an active role in hindering the penetration of carbonation.

Fig. 5. Relationship between $R + M$ thickness and total carbonation depth.

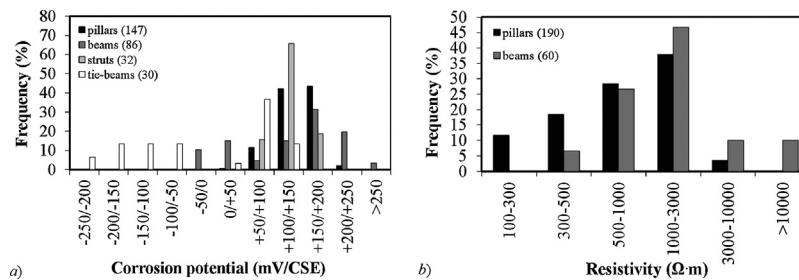
Potential values higher than 0 mV/CSE were measured on the rebars at floors below 15th and on some of the struts (Fig. 6a). The electrical resistivity, carried out on the external surfaces, without removing the render, was between 100 and 3000 $\Omega \times m$, with predominant values higher than 1000 Ωm (Fig. 6b). On the tie-beams the steel potential was measured on the surfaces more exposed to the rain and values between -200 and $+150$ mV/CSE were measured (Fig. 6a). The rather high values of electrical resistivity and corrosion potential, revealing that the elements below the 18th floor were relatively dry, even during rainy weather, suggested that the layers of render and mortar acted as a “barrier” and contributed to keep the humidity low in the inner concrete.

Fig. 6. Frequency distribution of steel potential of the reinforcement (a) and electrical resistivity (b) (number of data in brackets).
